12, PICKWICK, CORSHAM

Historic Building Report

P. M. Slocombe

2019

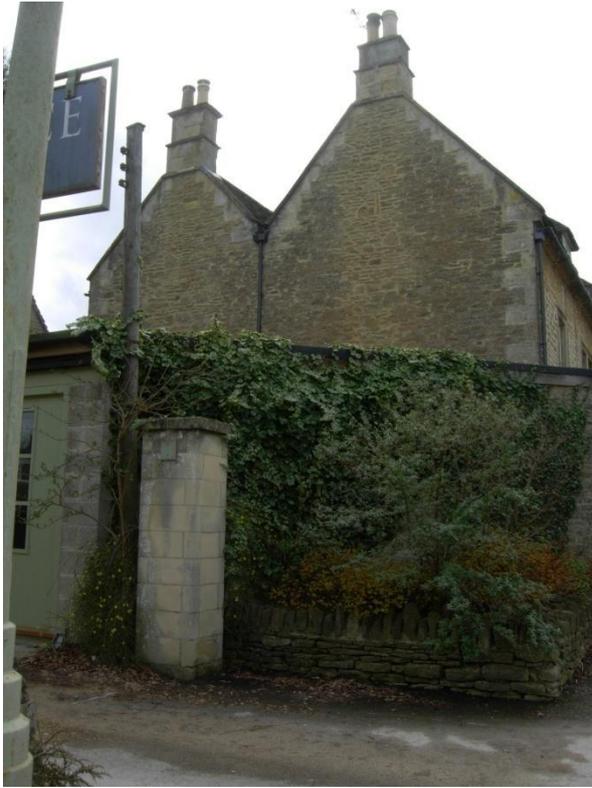
No. 12 from east with remaining side wall of the the demolished malthouse in the foreground.

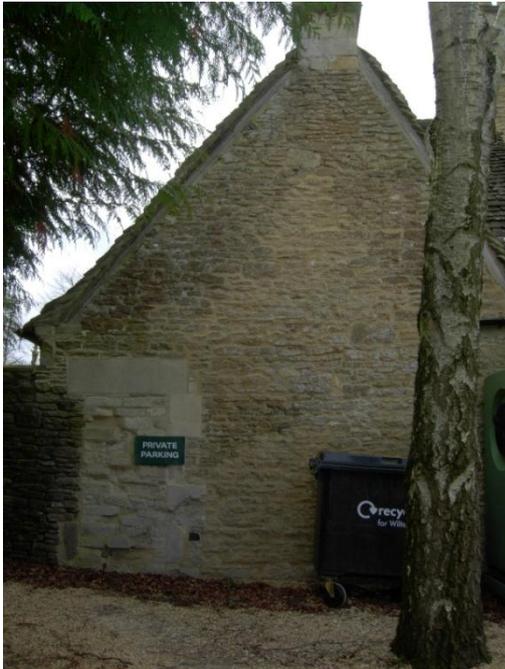
East wall of the brewhouse with blocked doorway and indications of a former lower gable.

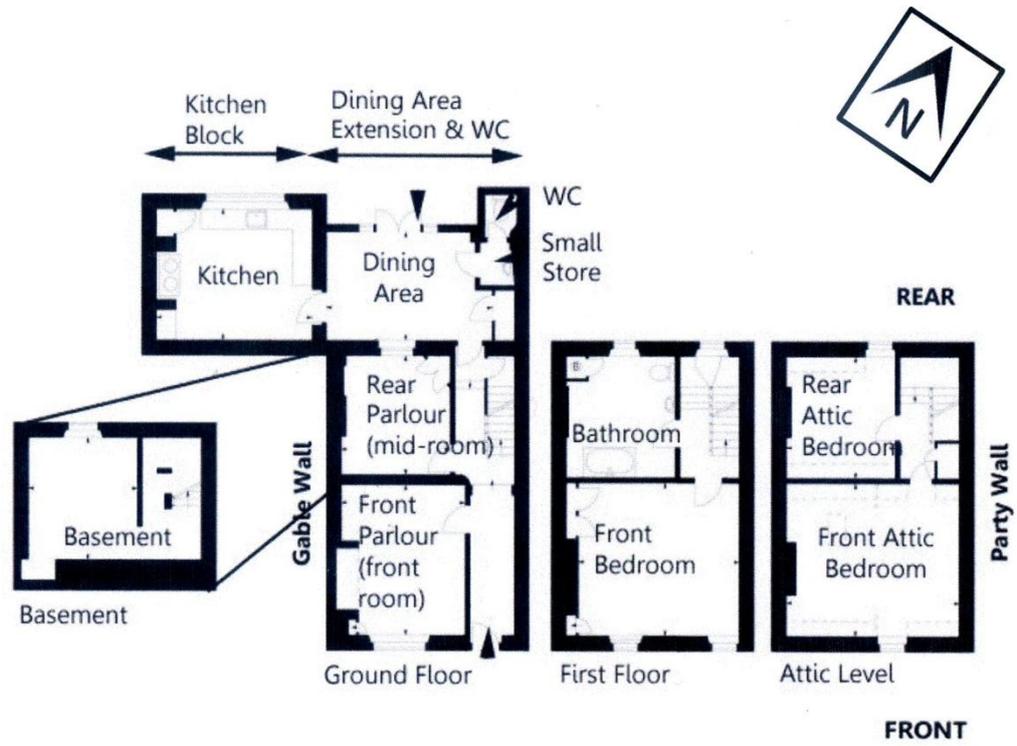
Sketch plan of no. 12 (Courtesy of Lyndon Smith)

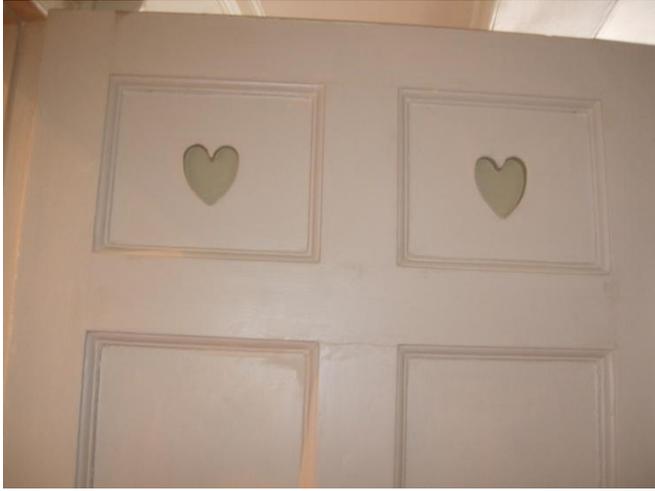
Door to front room

The entrance door to the room has heart-shaped cutouts to provide borrowed light to the hall. It has HL hinges. The stone fireplace in the east wall is, according to the owner, similar to others in the locality. It has an arched lintel and a large bead surround. The surround protrudes from the wall of the room and the outside of the jamb and the top of the lintel have a step/ogee moulding. The floor of the hearth is of flagstones with a flagstone apron in front. The rest of the room is floored with narrow planks. The rear wall of the hearth has a tall niche towards the south end and a curved wall with a narrow shelf at the north end. This suggests there was once a bread oven in the north wall of the hearth. The space between the fireplace and the front wall of the house is now occupied by a wall cupboard.

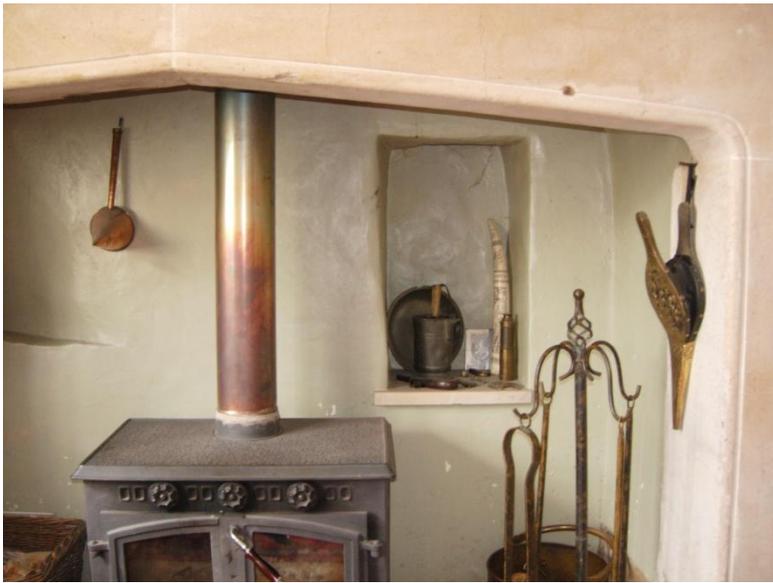
Front room fireplace

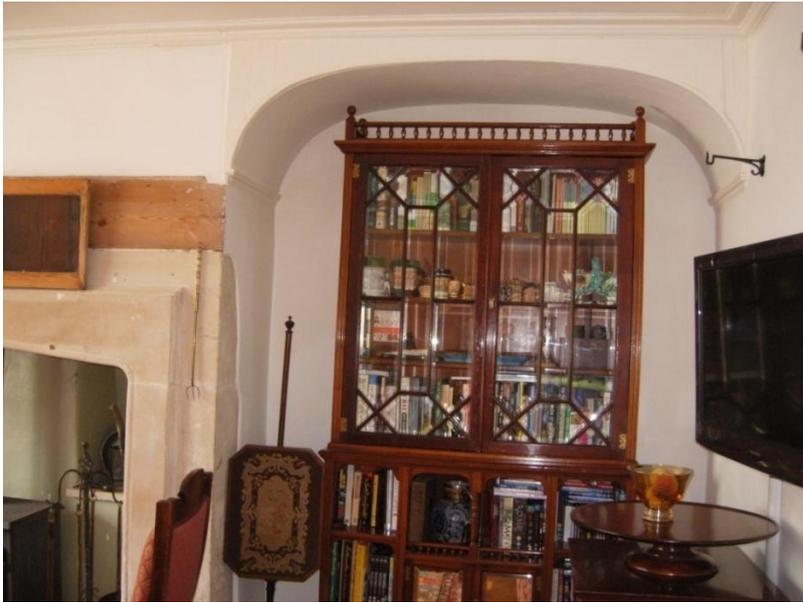
Arched alcove

South of the fireplace in the east wall there is a large arched alcove with a beaded surround. A corner cupboard in the north-west corner of the room was probably brought in. The cornice round the ceiling is interrupted over the front double-sash window but continues over the ceiling beam. This is another feature suggesting that the position of the windows has been raised. The moulding of the cornice, from the top, is bead/flat/step/quarter round/step. The beam has a large bead moulding. The sash windows have 12 panes and brass fixings.

4. The house seems to have had a refit around 1780 to make it more genteel. Earlier windows were perhaps then replaced by double sashes. A cornice was added to the front room ceiling and an arched alcove to the right of the fireplace. The front room fireplace was given a new surround with moulding similar to that of the architraves around the sash windows. The bread oven area in the fireplace was made into a cupboard. These changes made the room into a parlour rather than a living room. The existing stair was provided with new balusters and a stair arch was installed in the hallway. The rear ground floor room became more of a living room than a parlour. The cellar ceiling was lowered to provide more height in the room. The main reception room with a panelled dado was on the first floor.

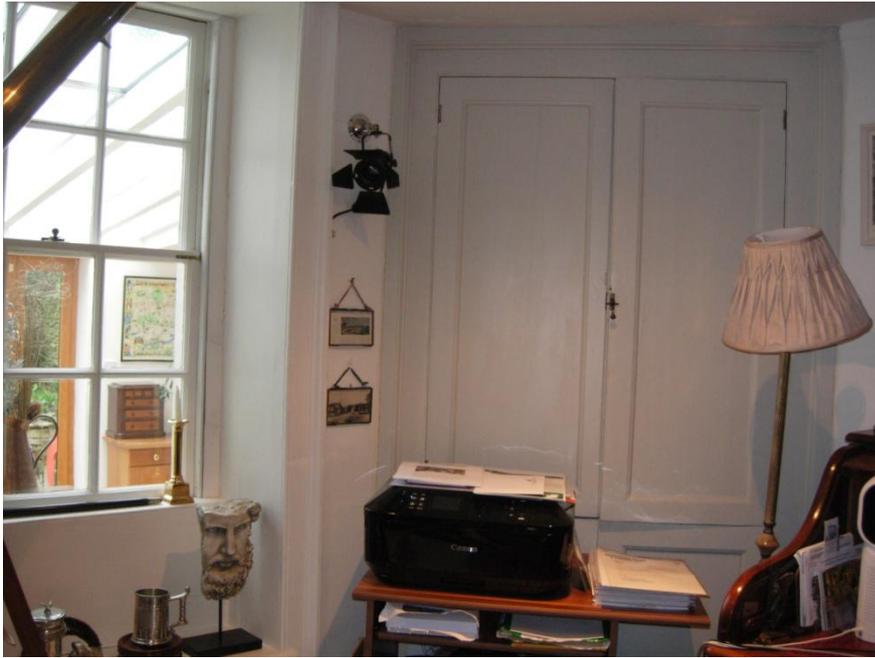
Corner cupboard

This is a step up from the front range. The entrance door to the rear room again has HL hinges. The fireplace on the east wall has a late 19th century grate with a green tiled surround. It has unusual rounded stands. There is a full height corner cupboard in the south-west corner of the room.

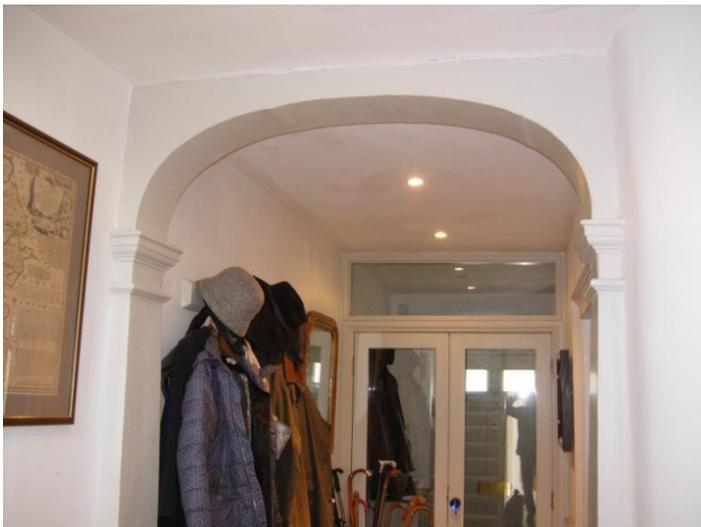
Staircase arch

There is a stair arch in the entrance hall. The newel post is tapered with ring mouldings at the top and bottom. The balusters match the newel post. There is one baluster to the tread. The handrail has a rounded top and is ramped on the landing.

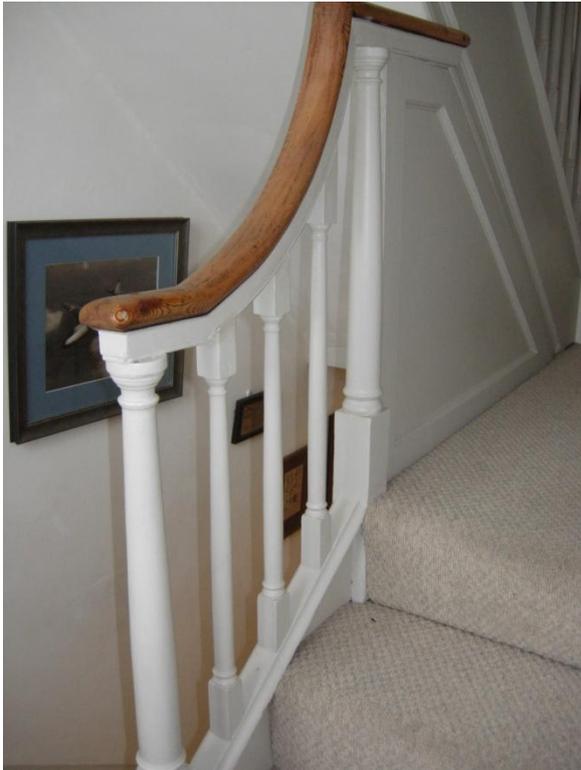
Staircase

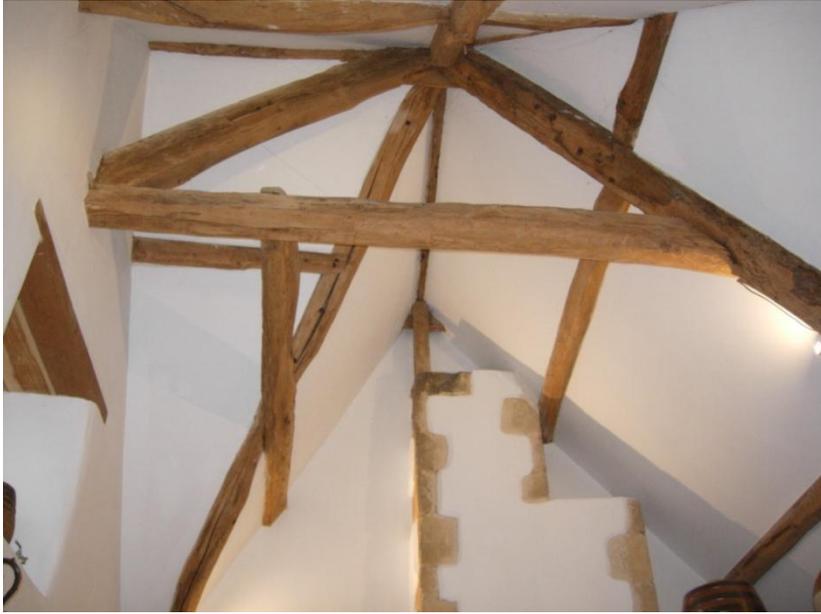
Extended collar looking east

The building is hipped to the south and west with gables to the north and east. To facilitate the north gable an extended collar truss was provided. This is a Cotswold type found extensively in Gloucestershire but also for a short period popular in north-west Wiltshire. In the variation here the timber acting as a collar at the south end acts as a tiebeam at the north end. The principal rafter on the south side, acting like a knee principal, has a curved foot and is a re-used cruck blade cut off just below the elbow. It is chamfered on both sides of the inner face and has a mortice for a former high collar. There is a mortice in the outer face at the elbow. The foot of this principal rests on the ceiling beam which is supported by a cast-iron pillar. This has been inserted at some date to replace the side wall, removed here to create a larger window. The extended collar is lapped onto the cruck blade and is tapered towards the north end. It is chamfered on the lower east soffit. It is also re-used and could be part of another cruck blade above the elbow. The short north principal is a re-used principal rafter as it has an old purlin joint in it with off-set pegholes. It also has a mortice which may be the former apex joint. The purlins in the roof are cut back at the principal rafters in the typical late 17th and 18th century way.

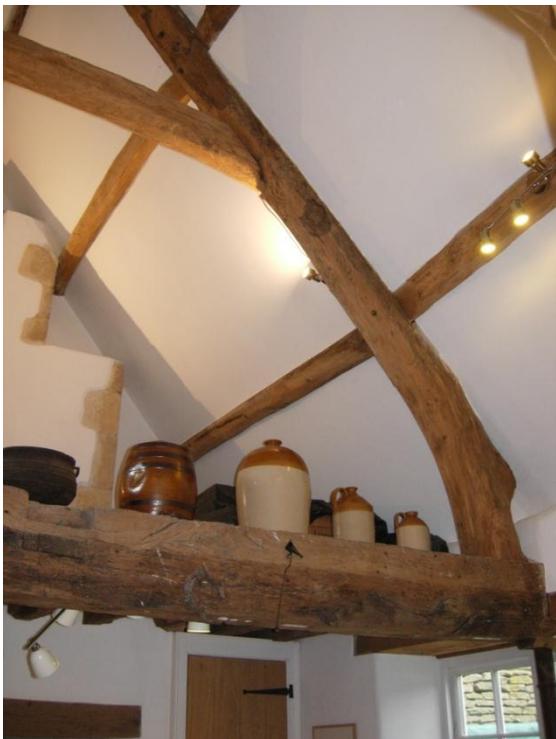
Cruck on ceiling beam

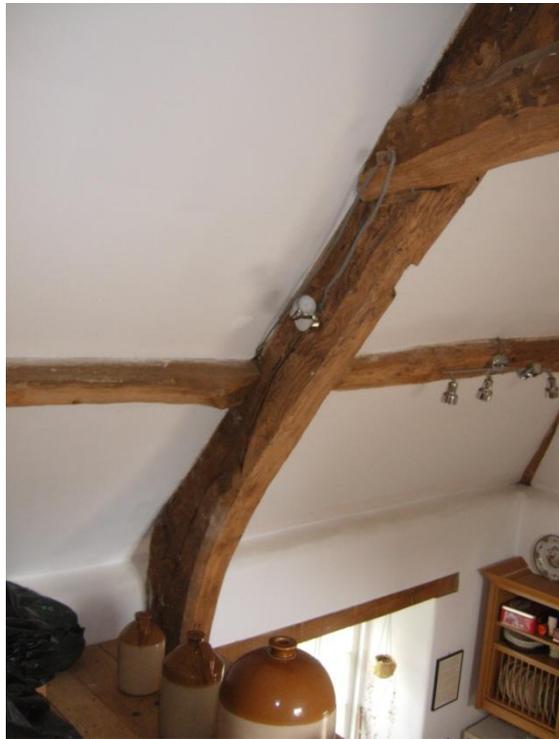
Cruck and lapped collar

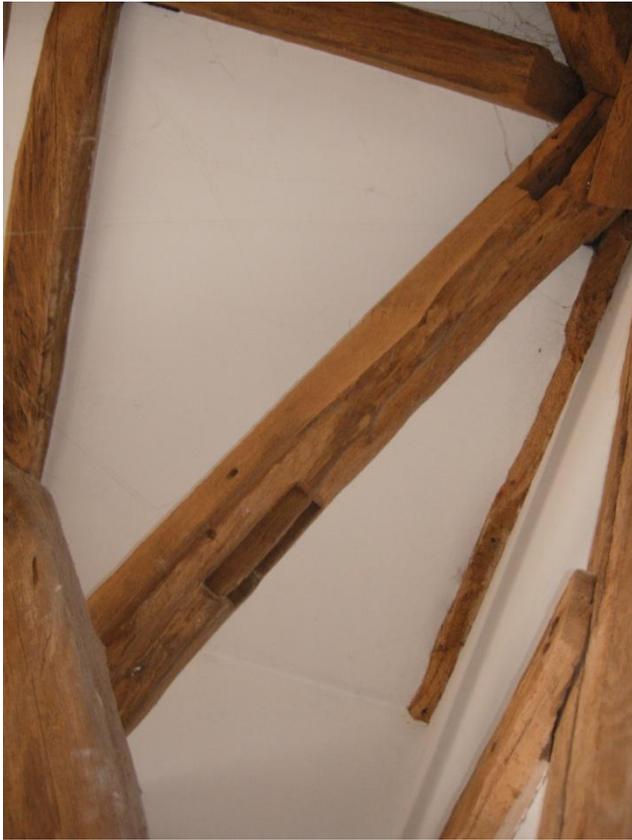
Old purlin joint in the north principal rafter

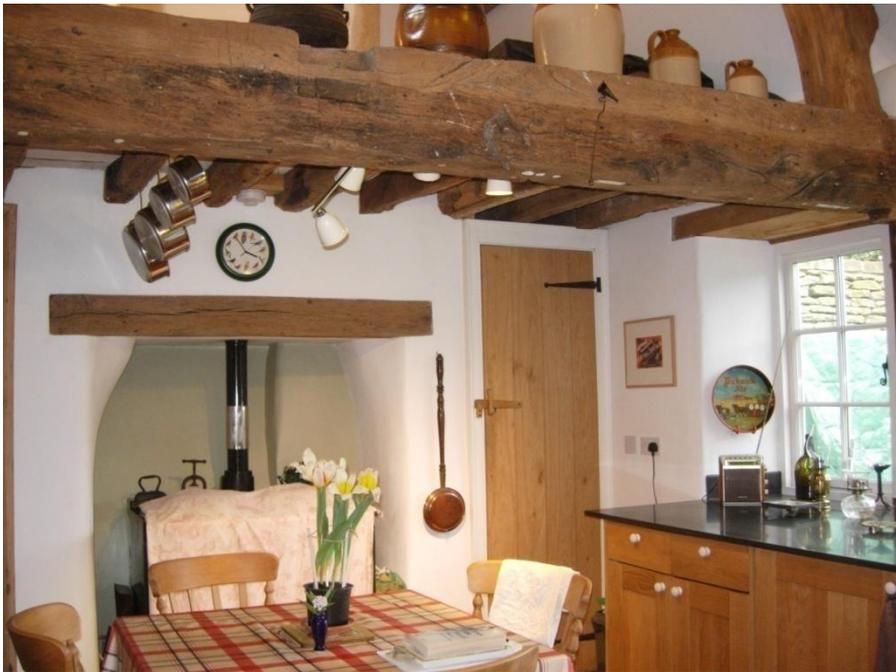
Beam and joists

There is a central ceiling beam or bressummer running north/south across the room supporting a half loft at the east end. The beam is somewhat smoke-stained and has a wide chamfer. It was tree-ring dated to 1534-40. In a former use it had been over a stud partition. The joists supporting the loft are also re-used timbers. Double V and butterfly protection marks have been found. The fireplace in the east wall is very altered but retains incurving side walls.

1. It seems likely that the re-used timbers dated 1534-1540 are from a house built on the footprint of the front ranges of nos. 12 and 14, parallel to the road. A number of the timbers have a degree of blackening but not soot encrusting which suggests some leakage of smoke in an early period, perhaps from a smoke bay rather than a fireplace. At that period the house could have been of timber or of stone. The re-used beam in the rear building (brewhouse) was previously a ceiling beam over a stud partition but in the 16th century stone houses often had timber partition walls. The plan of the 16th century house may have comprised a kitchen at the east end (with the fireplace perhaps surviving in the rebuild) and a parlour at the west end (suggested by an existing front cellar underneath no. 14). There would have been a hall (principal room) between and an entrance passage.

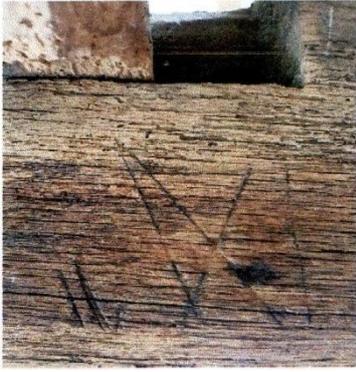
Butterfly mark

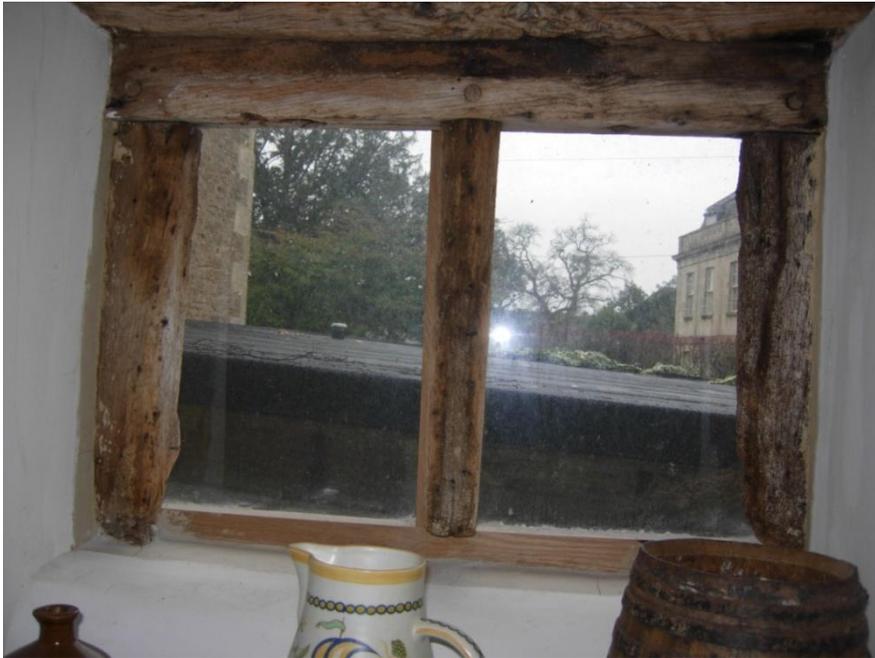
Timber window

There is a timber window in the north gable lighting the loft. It looks onto the site of the malthouse. It is very weather-worn and is probably reassembled. It has a plain chamfered lintel, mitred at the ends. The top half of the central mullion is chamfered.

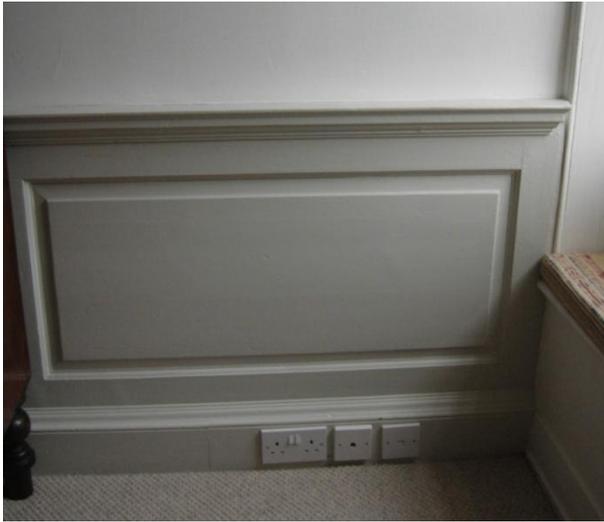
Dado

The room has dado panelling with a dado rail. The fireplace in the north-east corner has a beaded stone surround with a moulded timber surround outside. The flat lintel has curved corners. (A similar fireplace in Surrey has been dated to 1734.) It has a later hob grate. There is a mantel shelf.

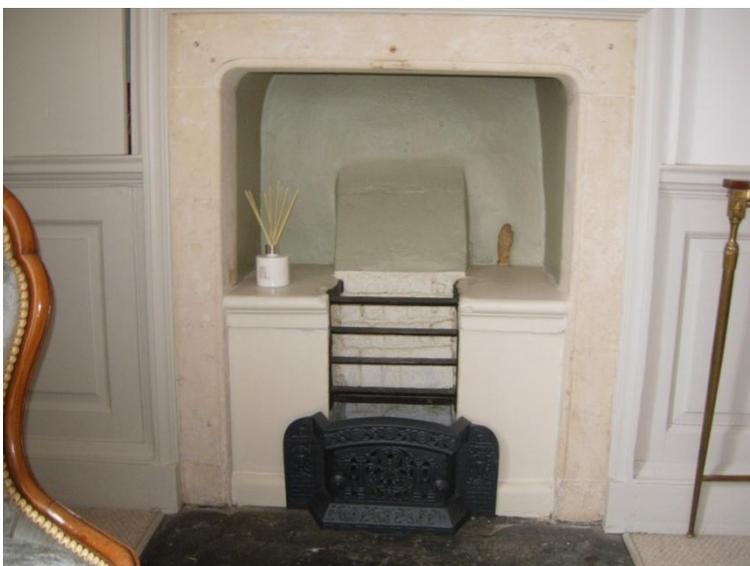
Front room fireplace

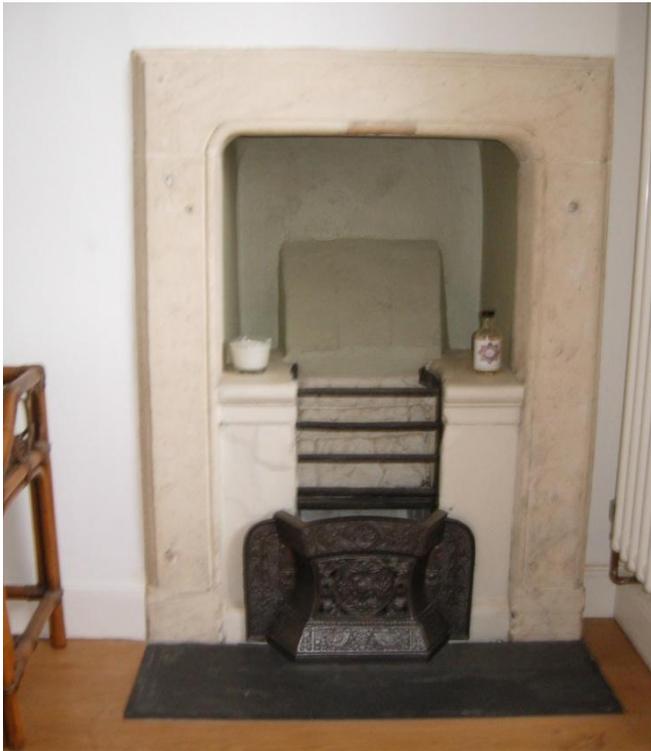
Rear room fireplace

This has a similar but smaller fireplace with beaded surround. It also has a hob grate inside.

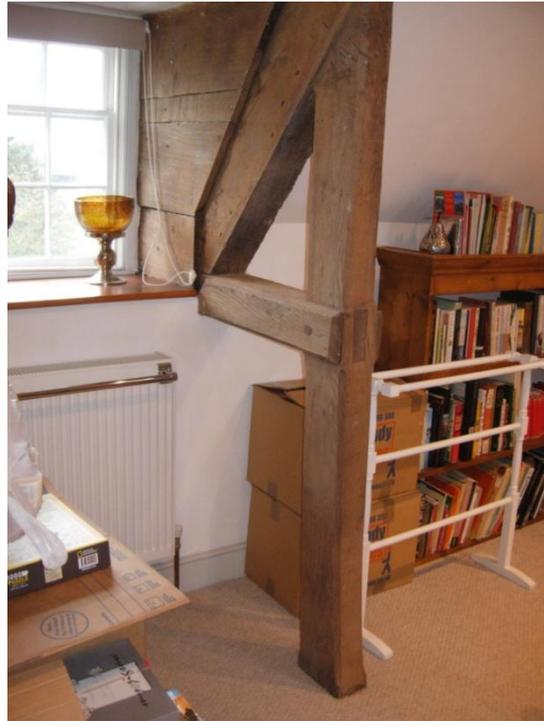
Truncated tiebeam

A two-panelled door leads into the room. The attic floor is below eaves level. The attic is lighted by a dormer window within the roof. The roof is very well carpentered and designed as a work room. The collar truss at the centre has truncated tiebeams supported on posts thus providing working space in the middle of the room. The timbers are chamfered. There are small chiselled carpenter's marks; an x and a matching 1 on the other side of the roof. Some of the purlins are re-used and some are waney. The south-east purlin was observed by Robert Howard during dendro sampling to have an unusual inscribed pattern, likely to be a protection mark; three concentric half circles with two small circles enclosed in the rings, another single half circle overlapping and a pointed spike from the concentric circles. Close to this there is a taper burn mark.

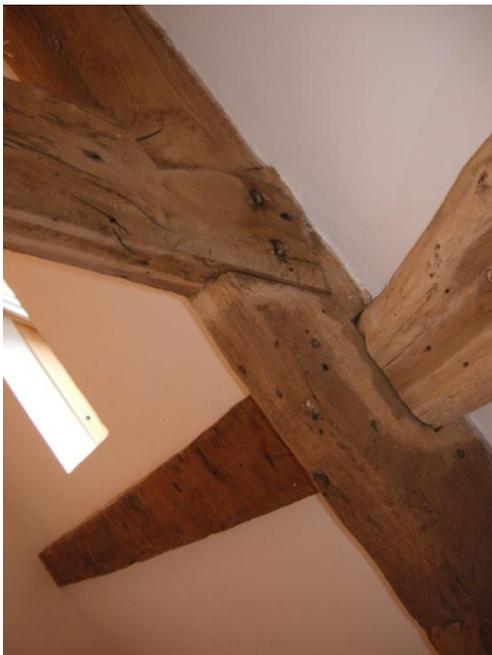
Lapped collar

The collar is lapped on to the principal rafters. The butt purlins have offset pegholes.

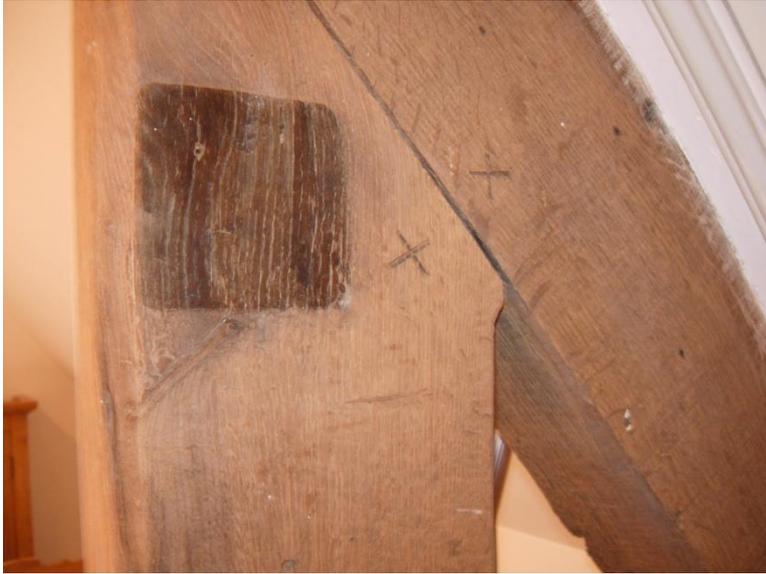
Carpenter's marks

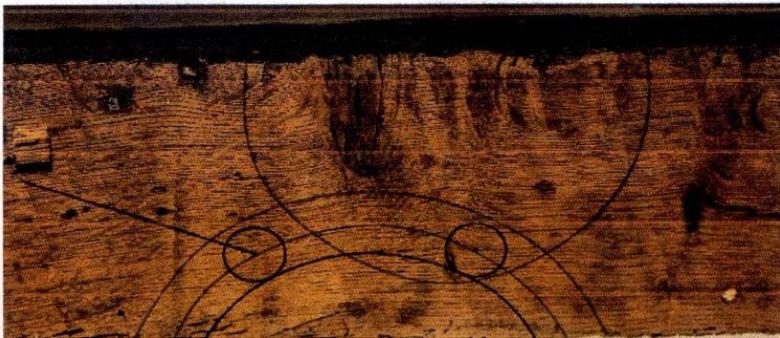
Protection marks, enhanced by Tony Hack
